DATE : April 17, 2001

SUBJECT: Radiation Survey, JPITT Melt Shop, Chicago, Illinois

FROM: Larry Jensen, CHP
Senior Health Physicist
Emergency Response Section #3

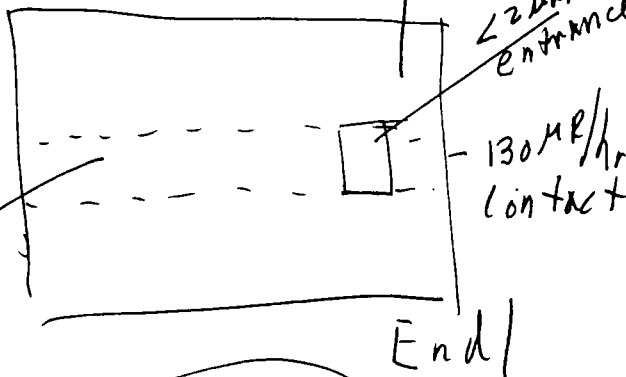
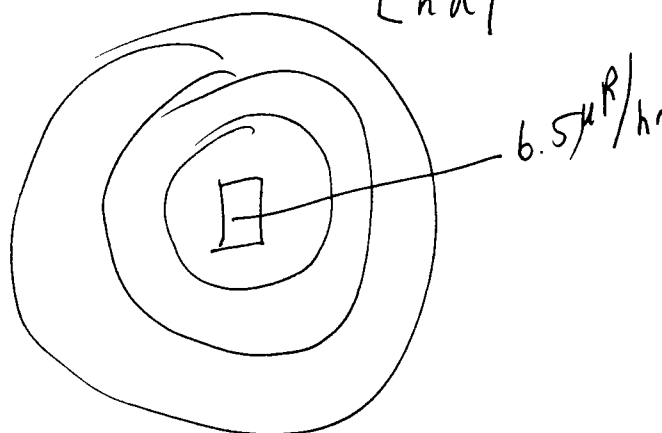
Side 1

Down
found at
East end of
building
2-4 $\mu R/hr$

2-3 $\mu R/hr$
contact
Cs-137
22 $\mu R/hr$
entrance

BK9 SAM
5-8 $\mu R/hr$

Cs-137

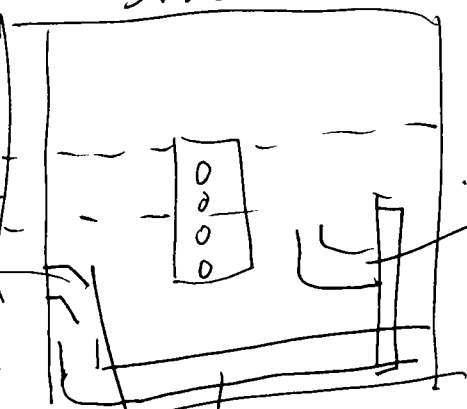
Side 2

130 $\mu R/hr$
contact

Hose
Connectors

Pipe?

Pipe
35-40 $\mu R/hr$ Cs-137

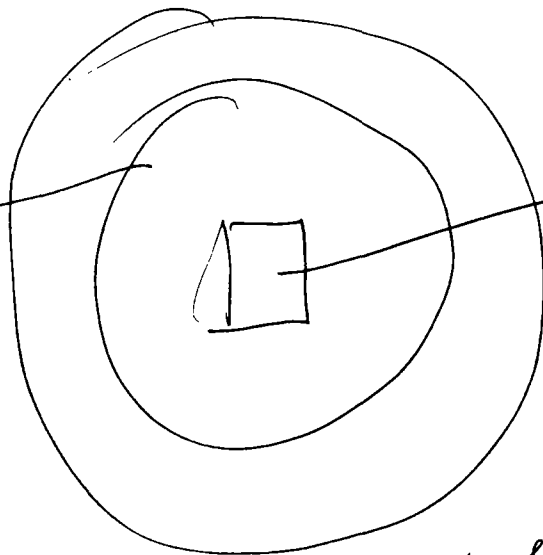
End ~

6-8 $\mu\text{R/hr}$
contact
(no isotope)

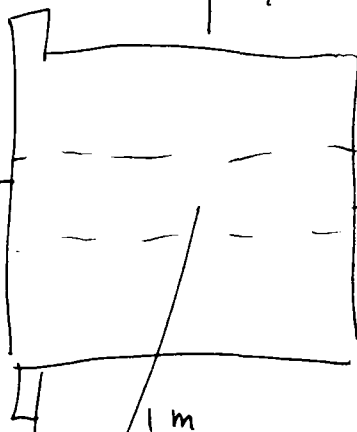
130 $\mu\text{R/hr}$
contact
Cs-137

8-9 $\mu\text{R/hr}$

1 m above
6-8 $\mu\text{R/hr}$

Backside at 1 m
6-7 $\mu\text{R/hr}$

Total 10-11 $\mu\text{R/hr}$
Cs-137 ~ 3 $\mu\text{R/hr}$

Readings at 1 meter
from each of
5 surfaces

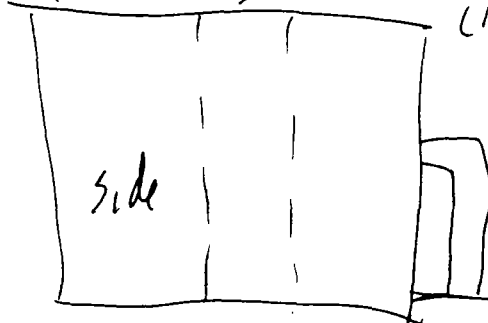
2 devices at west end of building
~~Top~~ End 135-155 ~~130~~ $\mu R/hr$ Cs-137
 150 $\mu R/hr$ Total (inside)

side

42 $\mu R/hr$ Cs-137
 50 $\mu R/hr$ Total

3 $\mu R/hr$ Cs-137
 11-12 $\mu R/hr$ Total

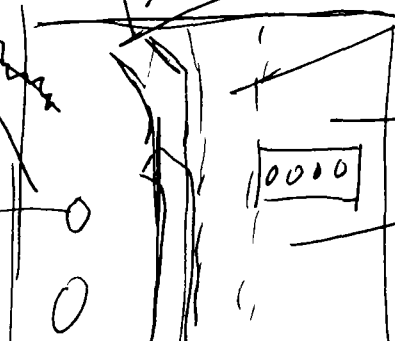
SIDE VIEW

30 $\mu R/hr$ Cs-137
 36 $\mu R/hr$ Total (flange)
 17-20 $\mu R/hr$ Cs-137

1 $\mu R/hr$ Cs-137

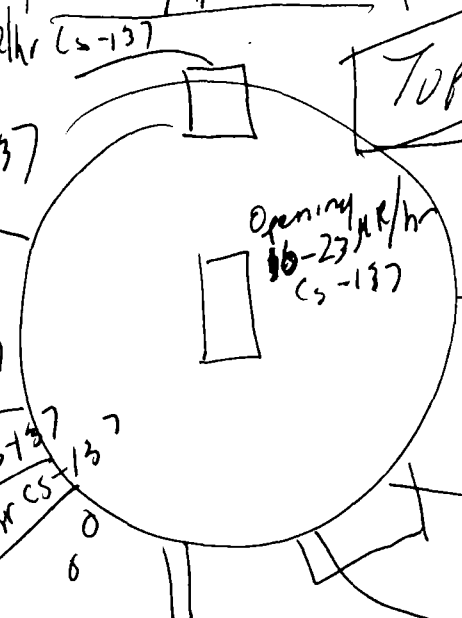
TOP VIEW

5-6 $\mu R/hr$ Cs-137
 5-7 $\mu R/hr$ Cs-137

2-3 $\mu R/hr$ Cs-137

1 $\mu R/hr$ Cs-137 under flange

30 $\mu R/hr$ Cs-137
 35-45 $\mu R/hr$ Cs-137
 44-50 $\mu R/hr$ Cs-137

17-20 $\mu R/hr$ Cs-137

30 $\mu R/hr$ Cs-137

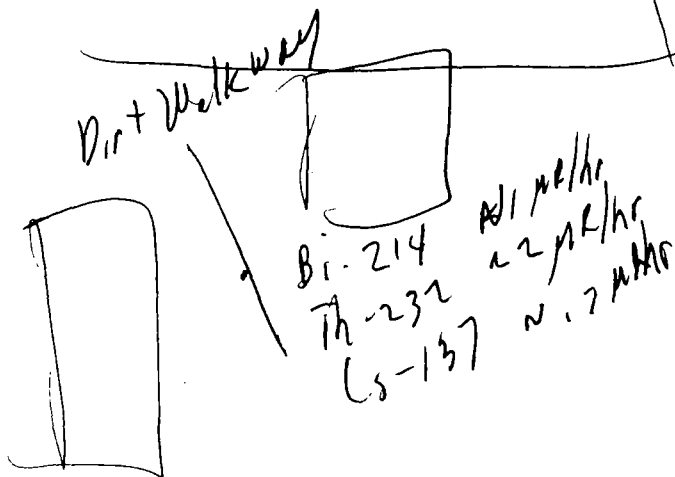
Elevated readings on dirt -

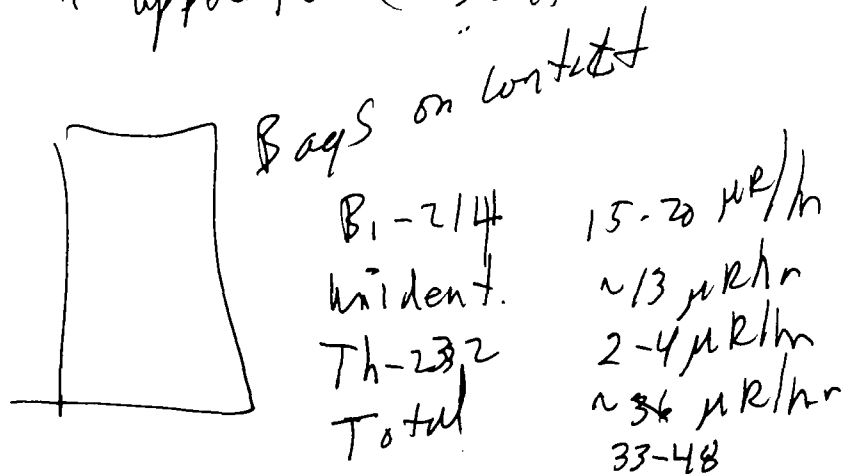
In addition to the 13 devices discussed above, there are numerous other radioactive materials in this building. These consist of bags of materials, "doughnut" shaped objects, disk shaped objects, formed materials, "dirt" and bricks. These were measured to be uranium and thorium materials, presumably unlicensed, uncontrolled Naturally Occurring Radioactive Materials (NORM). Our measurements show that they do not present a worker exposure problem. They are probably commercial materials that are not identified and treated as radioactive in the general environment. IDNS would be the determiner on official control issues. Mr Gulczynski and Ms Kark took 500 milliliters for spectral analysis of MarPatch-Z, a bagged material found on the upper level near the "caldron" that showed the highest count rate.

On upper level south of "caldron"

The licenses held by Charter Electric Melt and JPITT Melt Shop should be reviewed to see what sources were onsite. It should be determined if Charter transferred their license to JPITT and if JPITT officially terminated their license when they went bankrupt in 1997. Review of any closeout surveys by IDNS and/or NRC could help establish if there are remaining sources onsite. I would strongly recommend this for protection of our workers if nothing else, especially if IDNS does not plan to reenter the building until the chemical hazards are removed.

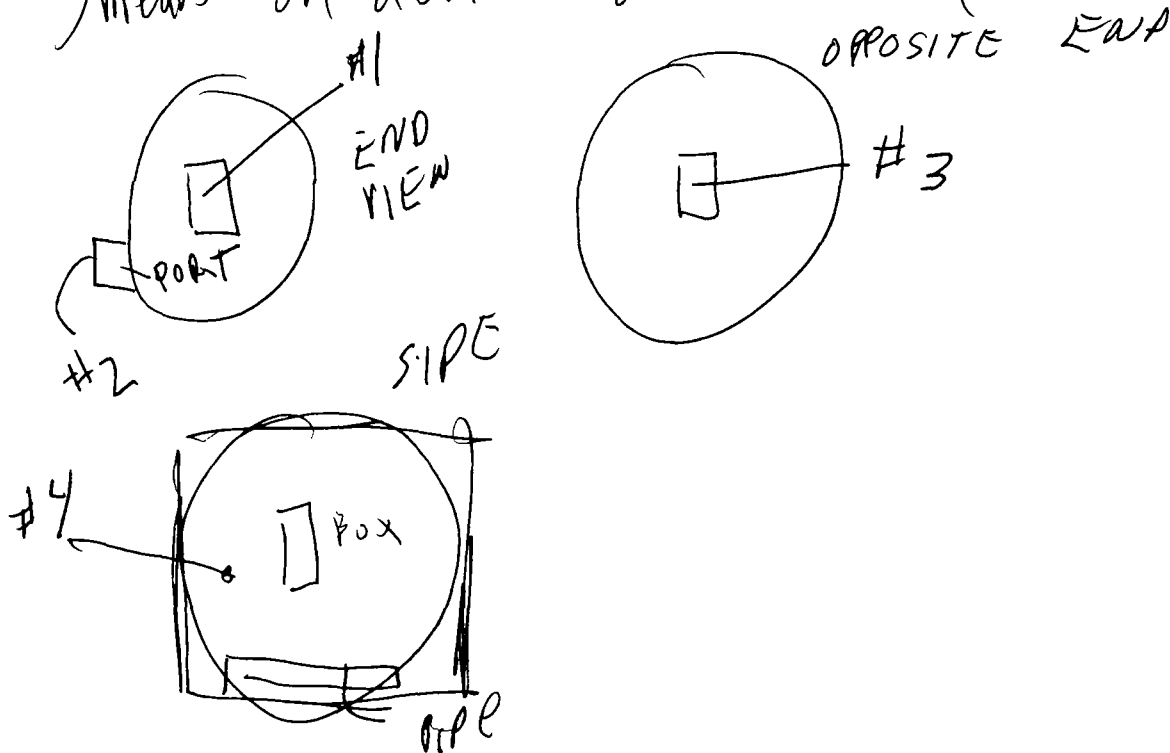
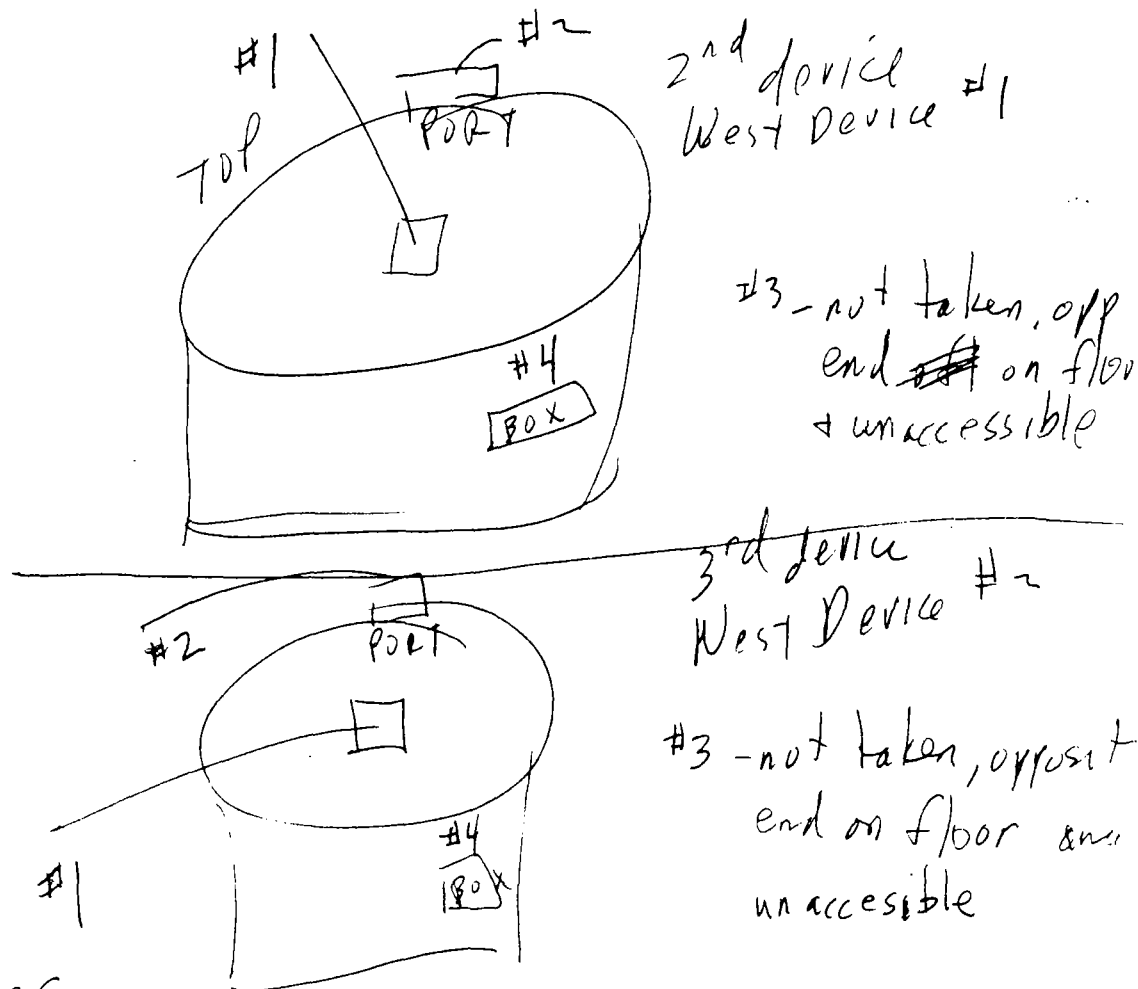
Smears on device at east end

Three of these were large cylinders, about 3 feet in diameter and about 3 feet high. The SAM detector established that they each contained a cesium-137 source. Exposure rates are shown on the attached sketches. These levels were low enough that response personnel can work in the vicinity without acquiring a significant dose. However, judging by the thickness of the lid, I believe that there is a strong source inside. Records showed that the previous owner purchased several 1.25 curie cesium-137 sources. If these are inside, removal of the lid could expose a source that could cause very significant dose or even death. Thus, in no case should these devices be dismantled. Smears taken on all three devices showed no removable material.
